Project Name: Gold King Mine – September 11, 2014	Site Location: Silverton, San Juan County, Colorado	Project No. NA
---	---	--------------------------

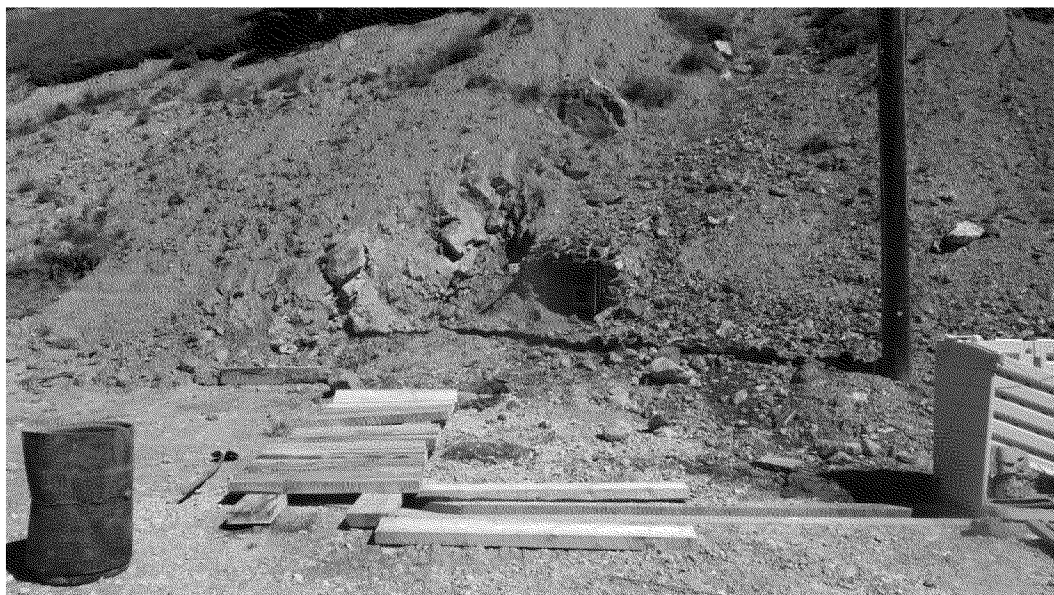
Photo No. 1	Date: 09/11/2014

Direction Photo Taken: North		
Description: Gold King Mine prior to 2014 site work. Photo taken on 9/11/2014 at 12:37 pm prior to start of work. 3-inch Parshall flume is at the right of the photo, in the plastic structure.

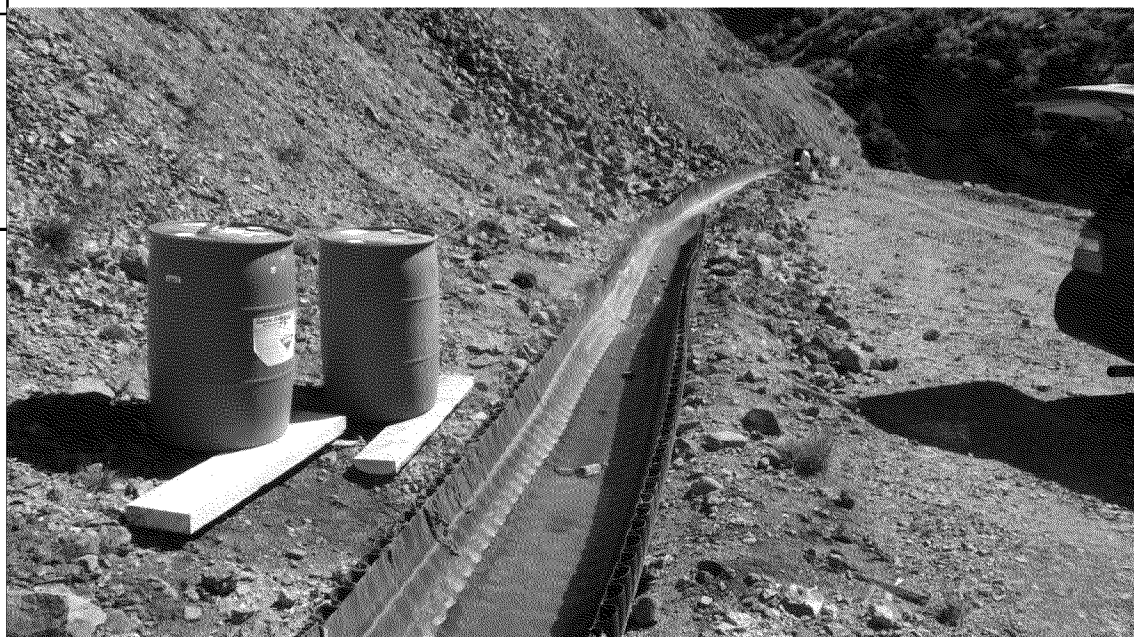
Photo No. 2	Date: 09/11/2014

Direction Photo Taken: East		
Description: Gold King Mine prior to 2014 site work. Photo taken on 9/11/2014 at 12:38 pm prior to start of work. Low flow in discharge channel.

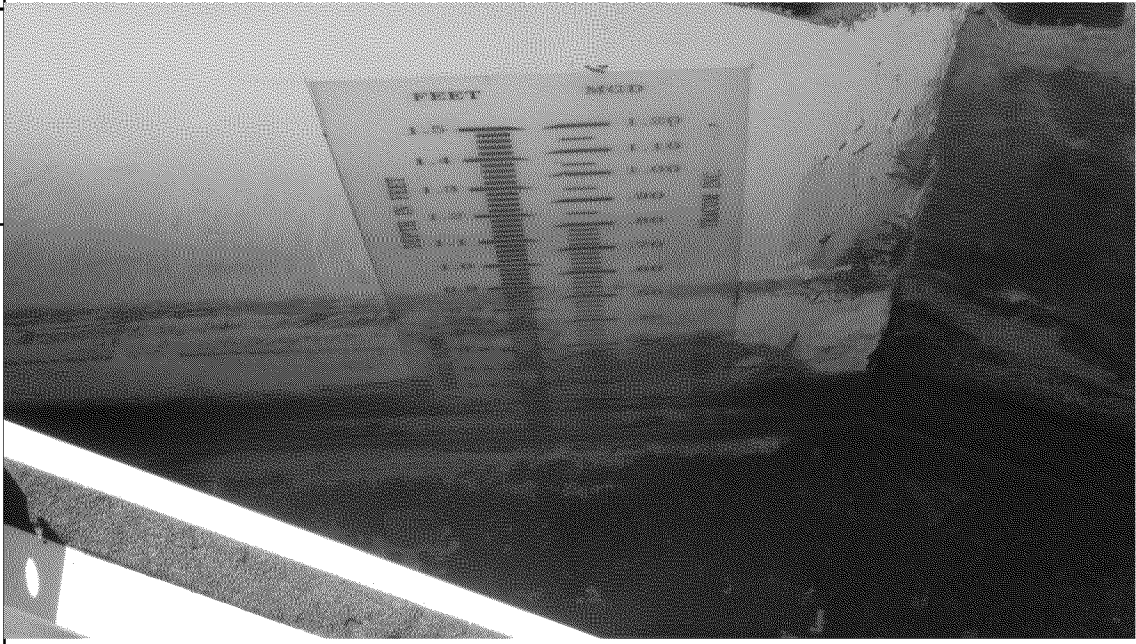
Photo No. 3	Date: 09/11/2014

Direction Photo Taken: South		
Description: Gold King Mine 3-inch Parshall flume. Note low flow in channel. Photo taken on 9/11/2014 at 12:42 prior to the start of work. Water is at 0.1 feet, which corresponds to 12.55 gallons per minute flow.

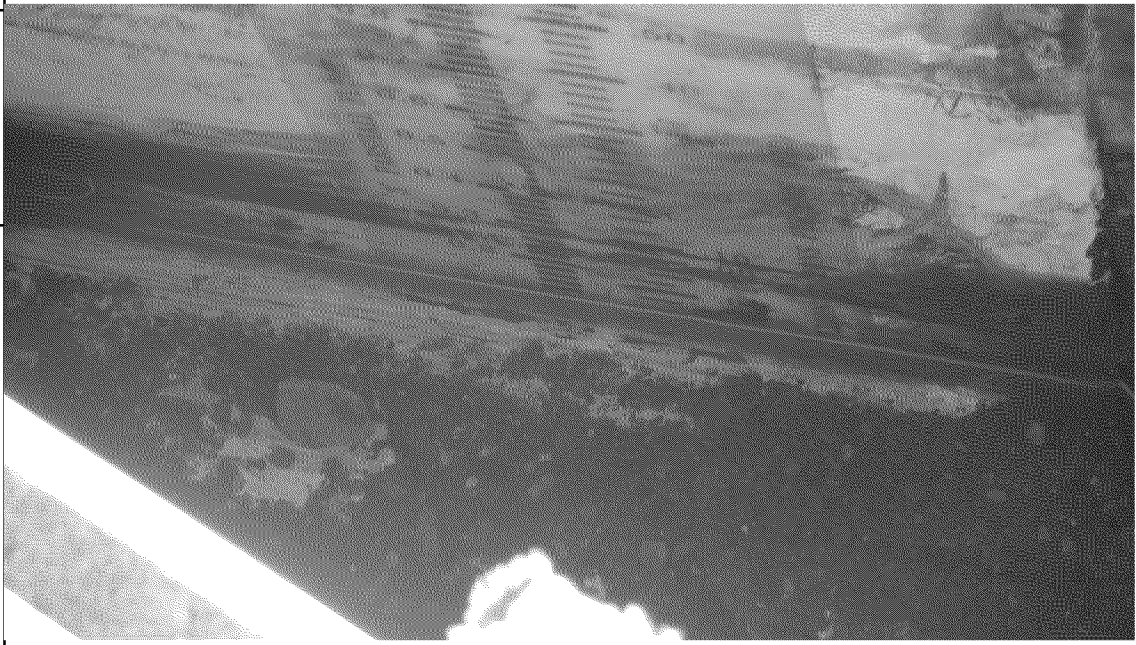
Photo No. 4	Date: 09/11/2014

Direction Photo Taken: South		
Description: Gold King Mine 3-inch Parshall flume. Note low flow in channel. Photo taken on 9/11/2014 at 12:43 prior to the start of work. Water is at 0.1 feet, which corresponds to 12.55 gallons per minute flow.

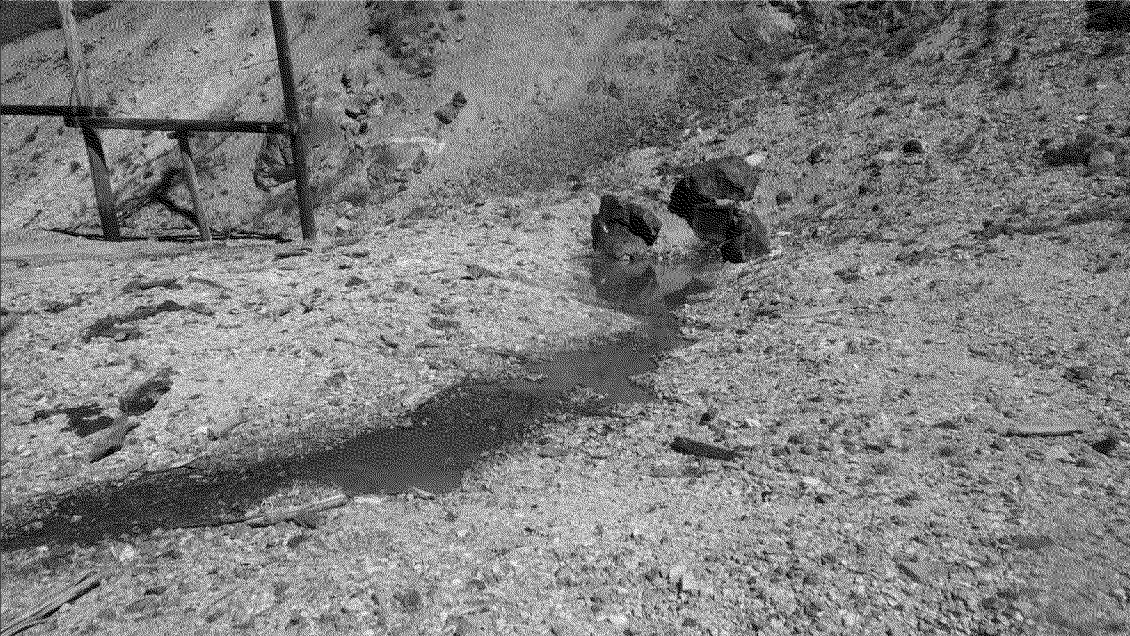
Photo No. 5	Date: 09/11/2014	
Direction Photo Taken: Northwest

Description: Small amount of flow from side adit approximately 100 feet west of main adit/flume. Photo taken on 9/11/2014 at 12:53.		
Photo No. 6	Date: 09/11/2014	
Direction Photo Taken: Northwest

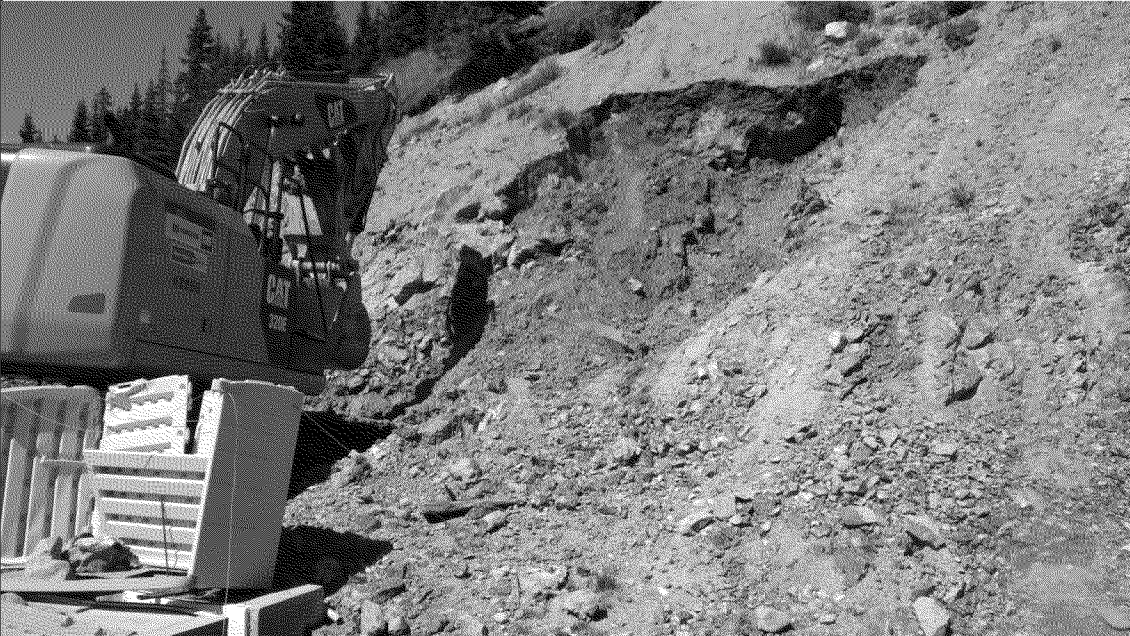
Description: Start of 2014 excavation work. Photo taken on 9/11/2014 at 15:10.
